**ENVIRONMENTAL, HEALTH & SAFETY PLAN
UNIVERSITY OF SA
DORRIT BLACK BUILDING & ENVIRONS
SOIL & GROUNDWATER CONTAMINATION
LIVERPOOL STREET ADELAIDE SA**

March 2014

DORRIT BLACK BUILDING & ENVIRONS

SOIL & GROUNDWATER CONTAMINATION

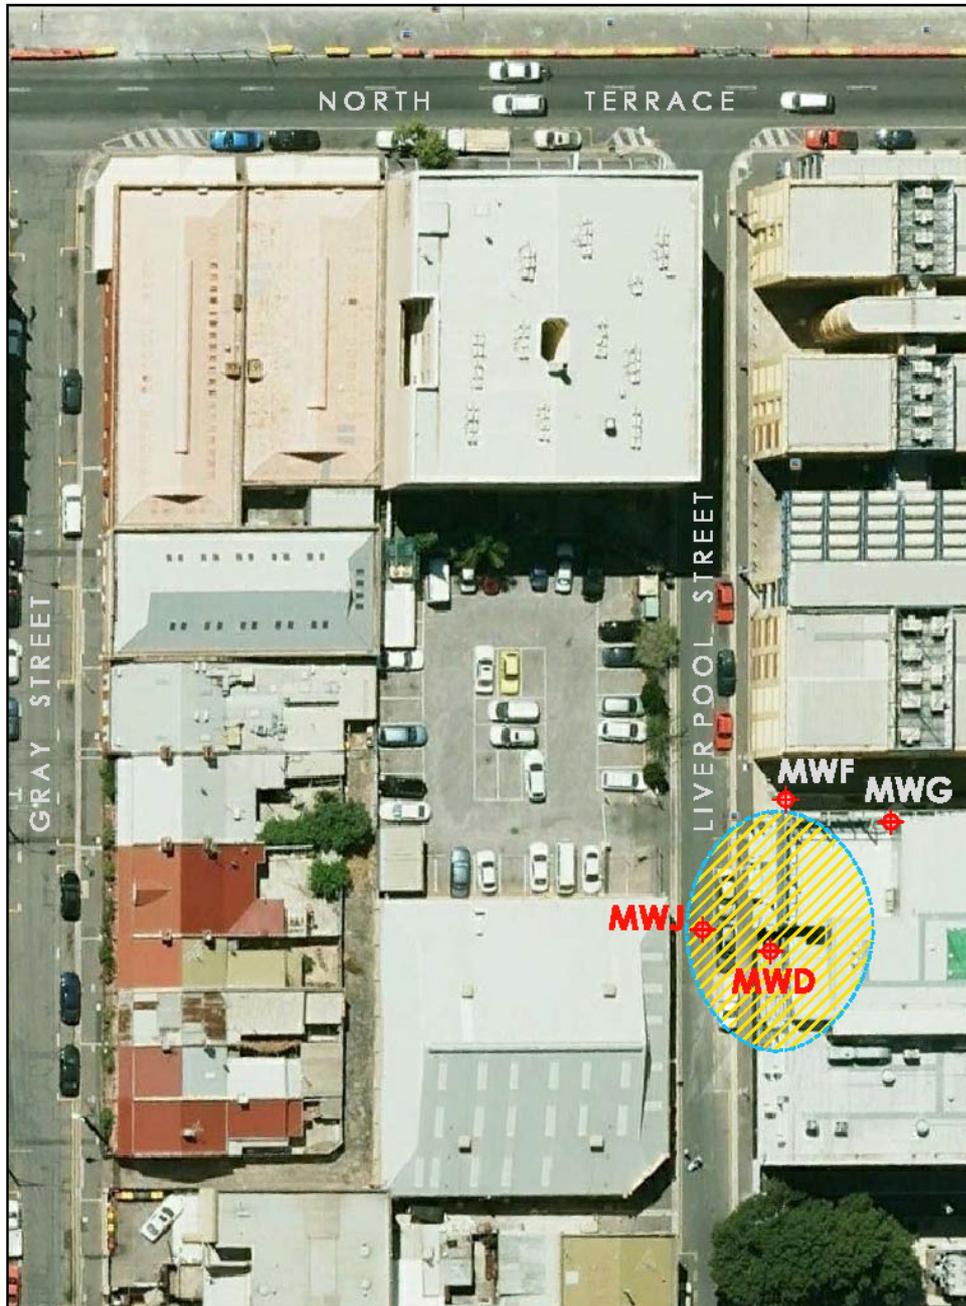
ATTACHMENT 1: CONTAMINATION ZONE PLAN

The extent and location of boundary of potential soil and groundwater hydrocarbon contamination including soil vapour within this location is depicted in Attachment 1. All site works conducted within the Contamination Zone are to comply with the EHSP.

DRAWING LOCATION PLAN
CLIENT: UNIVERSITY OF SOUTH AUSTRALIA
DESCRIPTION: ZONE OF CONTAMINATION AT: LIVERPOOL STREET ADELAIDE, S.A.

The body of contaminated groundwater lies some 6-7 m below ground surface and is overlain by natural soil strata to about 1-2 m from surface. The Contamination Zone is covered by the building footprint, pavement or bitumen roadway. Minimum potential for direct contact with the contaminated groundwater exists within the locality. A risk assessment conducted on behalf of UniSA by EnRisks in 2013 for soil vapour risks originating from the source contaminated groundwater body has concluded that no significant risk exist for building occupants (*“EnRisks, 2013, Soil Vapour Risk Assessment: University of South Australia, Site 2 George and Liverpool Streets Adelaide”* appended as Attachment B in Calabrese Partners Report No 0513-008-1 Sept 2013).
